State of Washington Department of Ecology Northwest Regional Office PERMIT COMPLIANCE INSPECTION REPORT		WADOE Permit Compliance Inspection Form Last updated 08/7/20													
SECTION A: GENERAL DATA																	
Inspection Date:	NPDES Permit #:	County:	Receiving Waters:	Inspector(s):	Facility Type:												
11/2/2022	WAR 305536	Whatcom	Bellingham Bay	Elizabeth Fint, Sylvia Graham, Mak Kaufman	Industrial												
Weather at time of inspection: °F																	
Discharges to: Surface Water <input checked="" type="checkbox"/> Ground Water <input type="checkbox"/>																	
SECTION B: FACILITY DATA																	
Name and Location of Facility Inspected Bellingham Shipping Terminal Port of Bellingham Alice Cords 629 Cornwall Ave. Bellingham WA 98225			Entry Time	Permit Effective Date													
			Exit Time	Permit Expiration Date

SECTION D: SUMMARY OF OBSERVATIONS AND FINDINGS

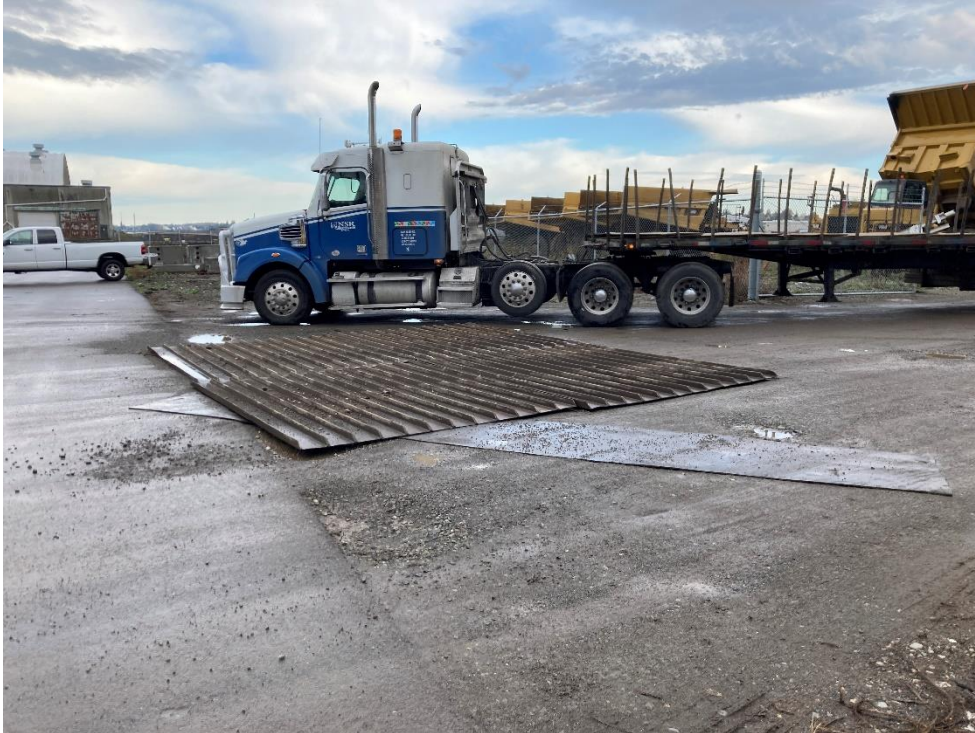
Photo 1

- The source control BMP (rumble pad ingress/egress) for vehicle and equipment track out at the access gate for ABC's stockpiles was bypassed by a truck maneuvering around the BMP. The BMP is meant to be driven over to reduce sediment and contaminant track out as vehicles move metal scrap to and from the stockpile area and moorage area.
- The Stockpile yard consisted of some gravel areas, deteriorating pavement, and sediment/mud. The yard was a large source of sediment and turbidity, and was not adequately stabilized to reduce pollutants from comingling with stormwater discharges.

- We began our inspection South near the Cornwall Ave. entrance and moved north towards ABC recycling's ingress/egress to the metal stockpiles. We watched a haul truck purposefully drive *around* the rumble pad (photo 1), contributing to the track out observed (photo 2).

Description: Flatbed truck purposely bypassing the track out BMP while exiting the stockpile yard. Bypassing the track out BMP doesn't reduce track out of sediments and other pollutants from the stockpile yard.

- **Special Condition S3.B.4.v.** requires the permittee to implement BMPs necessary to prevent the erosion of soils and other earthen materials, control off-site sedimentation, and prevent violations of water quality standards.

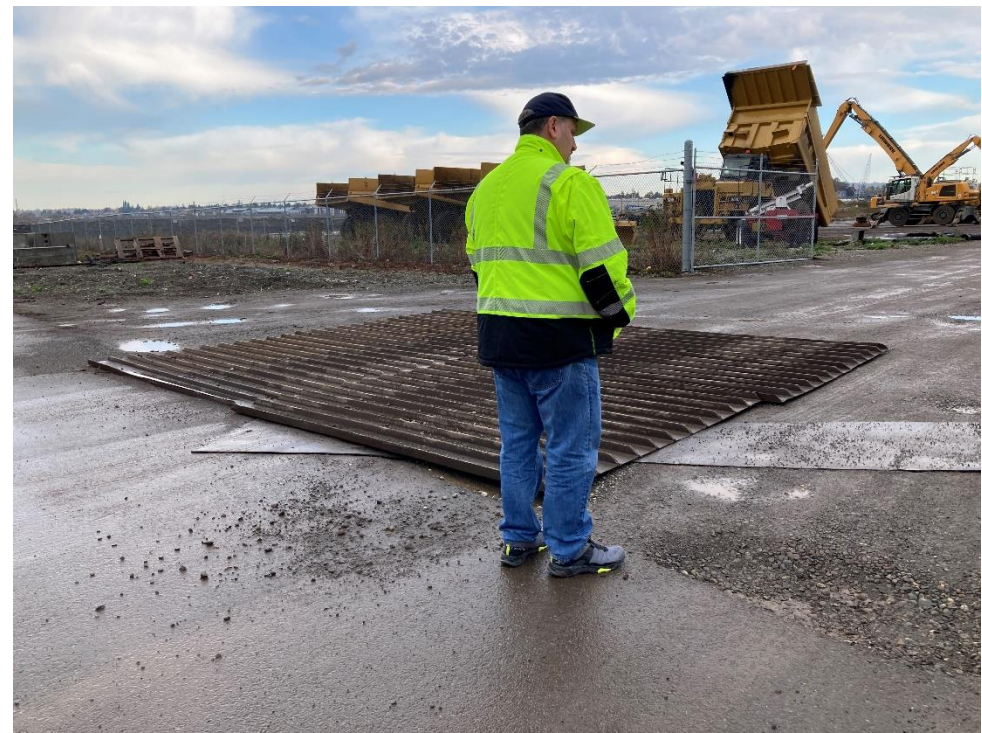
Photo 2

Description: Sediment and debris tracked out to pavement from trucks bypassing the track out BMP.

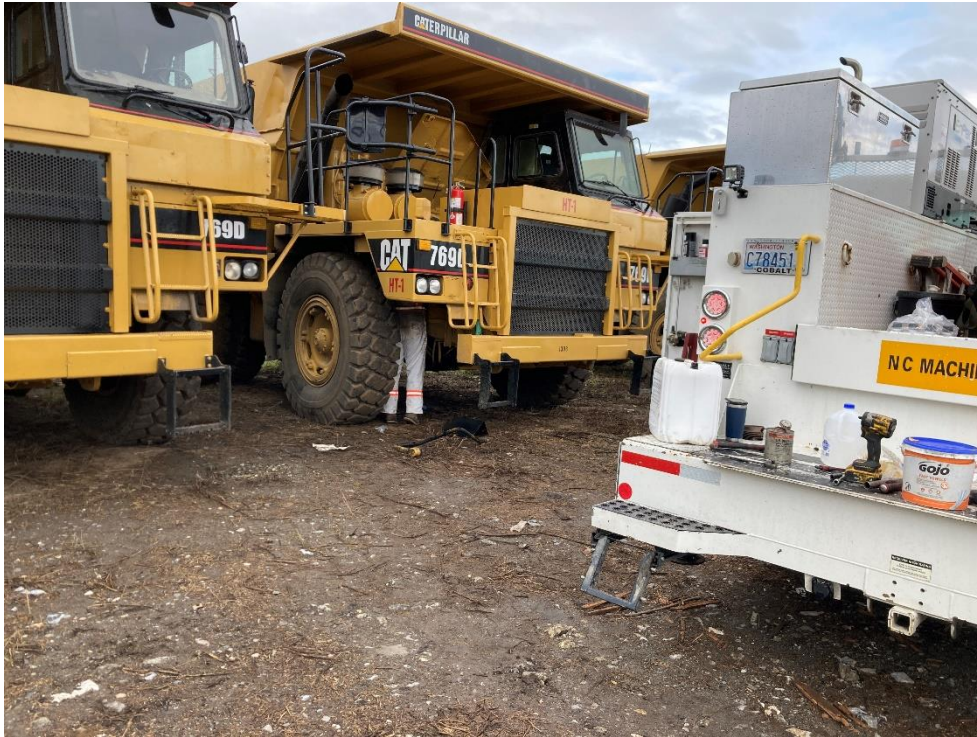
Photo 3

- Vehicle maintenance activities were being performed outdoors in ABC's stockpile yard at the time of inspection. The mechanic was fixing two vehicles with no cover or containment of parts, contaminants, or fluids.

- Near the stockpile entrance, a mobile mechanic was actively repairing two broken vehicles, without cover and exposed to stormwater (photo 3). Andy said they are installing a half dome covered space for maintenance and storage. They are also bringing two storage containers on site to store spill materials, lubricants, and other misc. items.

Description: Mechanic actively repairing two pieces of heavy equipment without cover or containment to reduce pollutants from comingling with stormwater.

- **Special Condition S3.B.4.b.i.4.g** requires the permittee to locate materials, equipment, and activities so that leaks are contained in the existing containment and diversion systems.

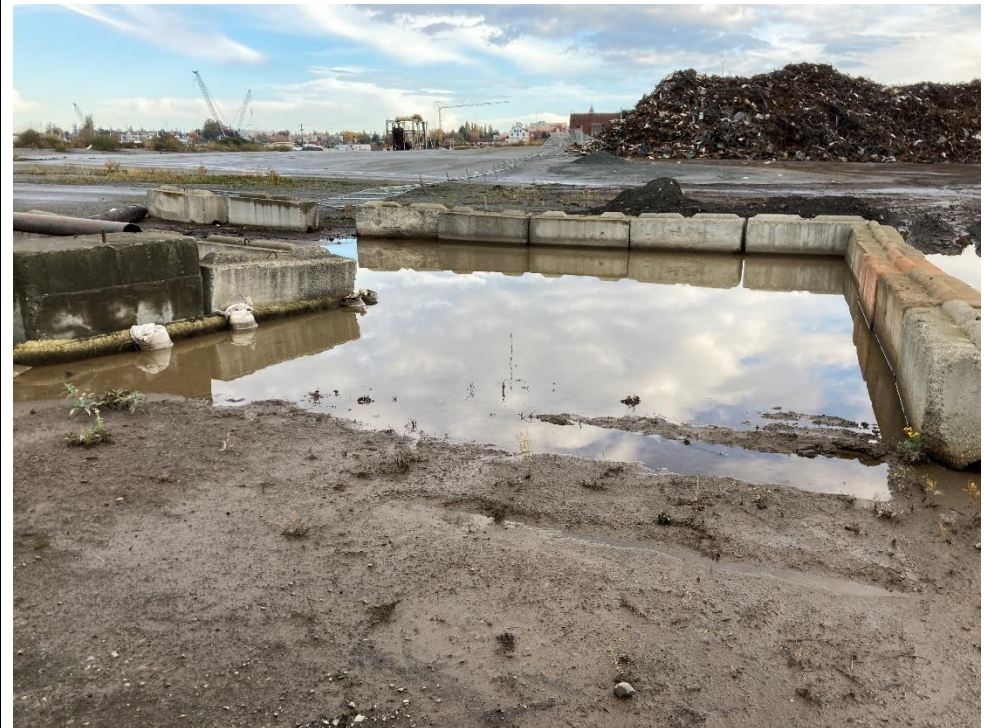
Photo 4

- The stormwater vault collects stormwater dischargers from the strip drain north of site as well as ABC Recycling's stockpile yard. At the inspection, the Port said the vault was last serviced about 6 months ago but could not provide an exact date or record of maintenance.
 - **Special Condition S3.B.4.b.i.3.b** requires the permittee to maintain ponds, tanks/vaults, catch basins, swales, filters, oil/water separators, drains, and other stormwater drainage/treatment facilities in accordance with the maintenance standards set forth in the applicable Stormwater Management Manual for Western Washington (SWMMWW).
 - **Appendix V-A: BMP Maintenance Tables from the SWMMWW** requires maintenance of stormwater vaults when accumulated sediment depth exceeds 10% of the diameter of the storage area for 1/2 length of storage vault or any point depth exceeds 15% of diameter.

- We walked parallel to the stormwater trench north of site, heading east, that intercepts stormwater from ABC's working footprint and discharges to the stormwater vault centrally located in ABC's operating yard (photo 4). From there the stormwater is eventually pumped to Port of Bellingham's aeration stabilization basin (ASB). The stabilization basin is lined to prevent infiltration to the bay, however, the ASB does have an outfall pipe to the bay as well as an emergency overflow. The port said the pipe is closed and does not currently discharge to the bay.

Description: Stormwater vault located approximately in the middle of ABC Recycling's stockpile yard. Vault was full of turbid water and sediment accumulation surrounded the vault.

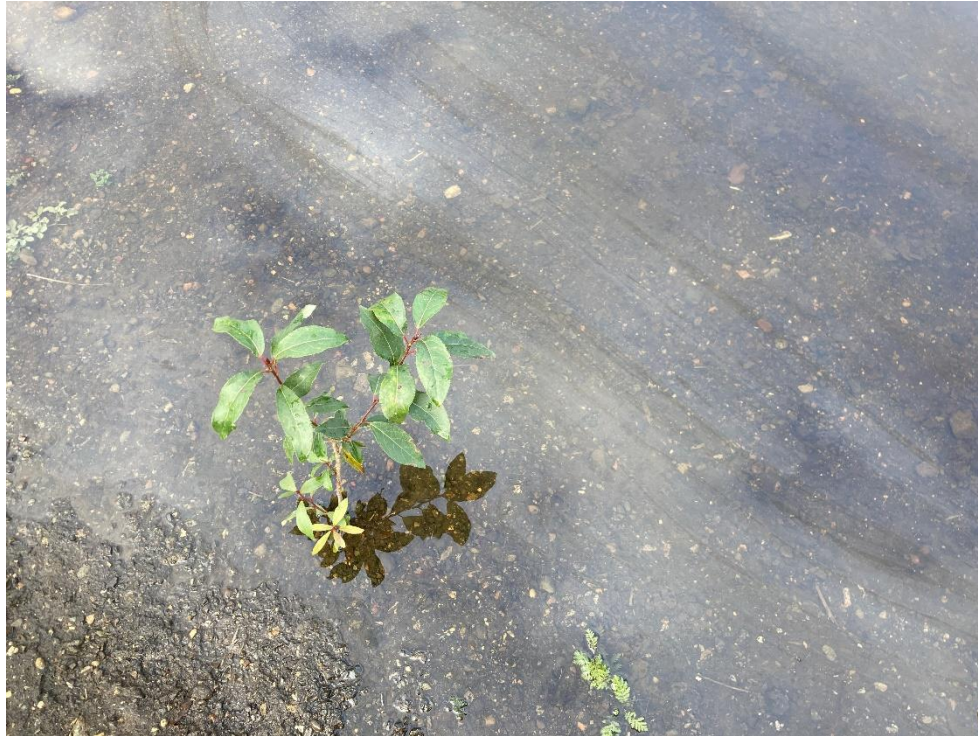
Photo 5

- We observed petroleum sheen, emulsified oil, as well as petroleum spills/leaks on the ground and in stormwater puddles throughout ABC Recycling's stockpile yard (photos 5 and 6). There were no operational, structural, or treatment BMPs in place to prevent contamination of stormwater or to treat or prevent contaminated stormwater from leaving the site. The petroleum sheen and emulsified petroleum throughout site was egregious. We did not observe any spill kits in the stockpile area. Oil sheen was also observed near the moorage area (middle wharf) at catch basin B2A. Dave was able to grab some floor dry and clean-up the spill during the inspection (photo 7).

Description: Oil sheen floating on top of a stormwater puddle in ABC Recycling's stockpile yard.

- **Special Condition S3.B.4.b.i.3.d** requires the permittee to clean-up spills and leaks *immediately* to prevent discharge of pollutants.
 - **Special Condition S3.B.4.b.i.4.g** requires the permittee to locate materials, equipment, and activities so that leaks are contained in the existing containment and diversion systems.

- **Special Condition S3.B.4.b.iii.2** requires the permittee to employ oil/water separators, booms, skimmers, or other methods to eliminate or minimize oil and grease contamination in stormwater discharges.

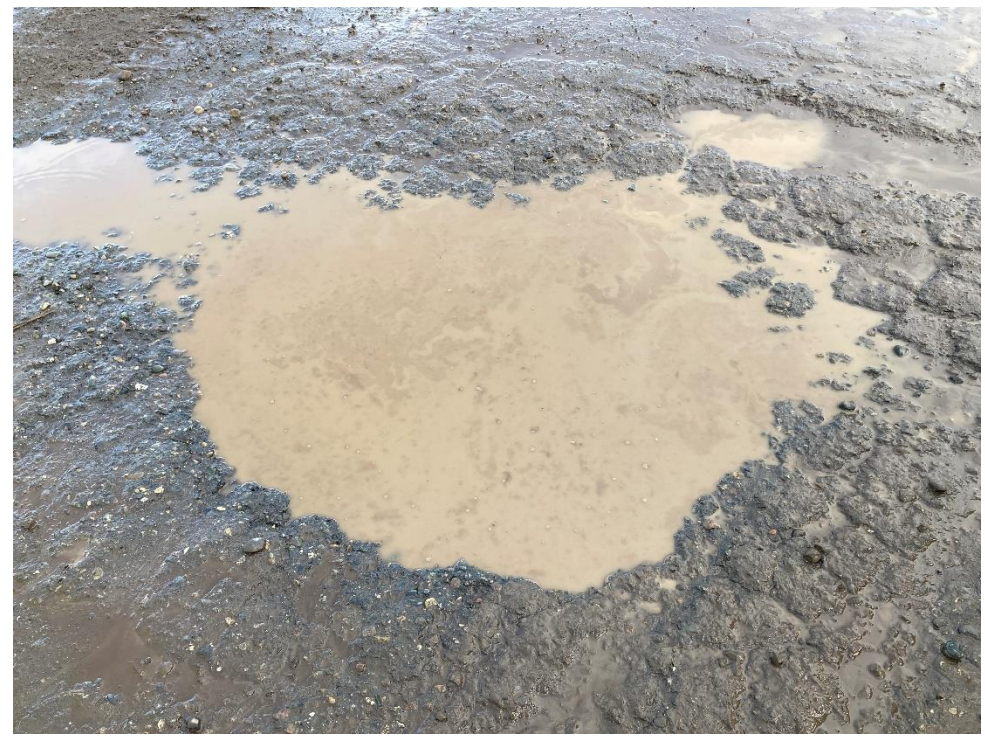
Photo 6

Description: Emulsified oil/petroleum mixed with stormwater in ABC Recycling's stockpile yard.

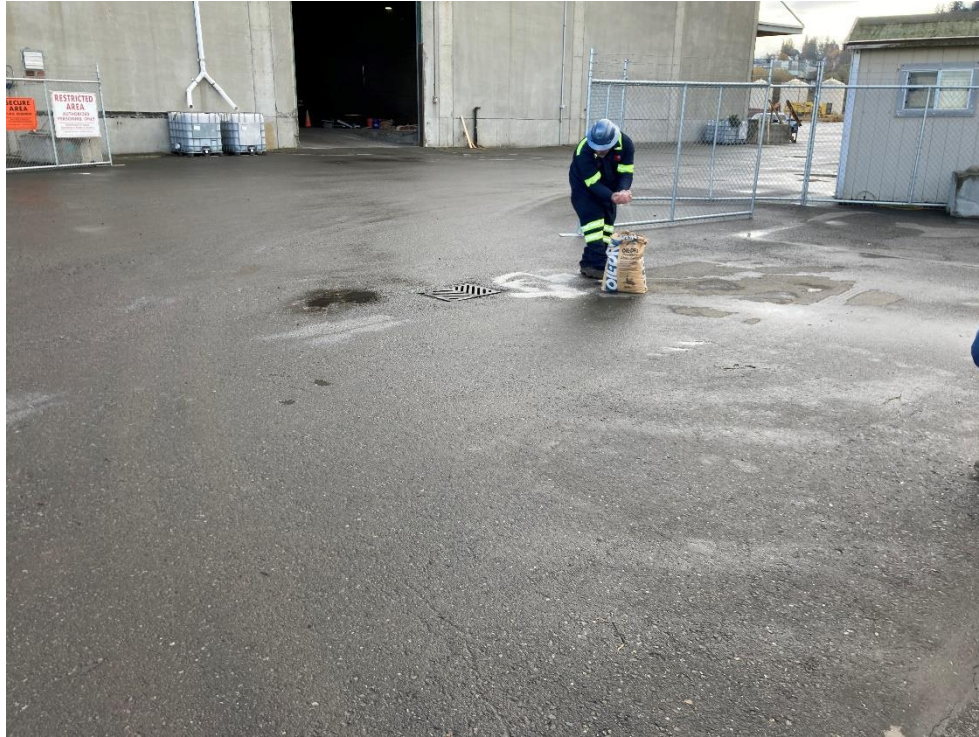
Photo 7

Description: Petroleum spill clean up at catch basin B2A.

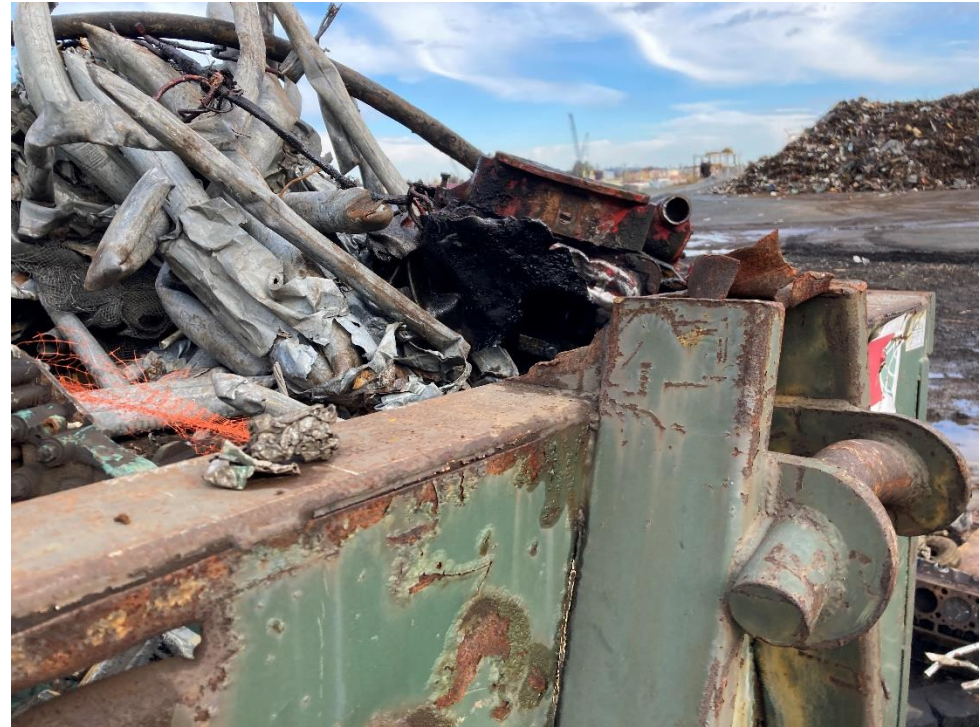
Photo 8

- ABC recycling uses dumpsters to deposit trash metal items that will not be recycled. Ecology observed at least two trash dumpsters with no lids/covers – lids/cover are required on dumpsters to prevent stormwater from comingling with the contents of the trash dumpsters to prevent contamination of stormwater.

- Andy said ABC does not sort piles on site, but if they see an item that is not allowed in the pile, they will pull it out and put it in the roll-off trash dumpsters. The roll-off trash dumpsters observed during the inspection had items that were covered in oil/grease (photo 8). The dumpsters did not have lids or covers to prevent stormwater from comingling with contaminants.

Description: Trash items removed from recycling piles – trash items have oil/grease residue exposed to stormwater – dumpsters did not have a cover or storm proof lid.

- **Special Condition S3.B.4.b.i.2.d** requires the permittee to keep all dumpsters under cover or fit with a storm resistant lid that must remain closed when not in use.

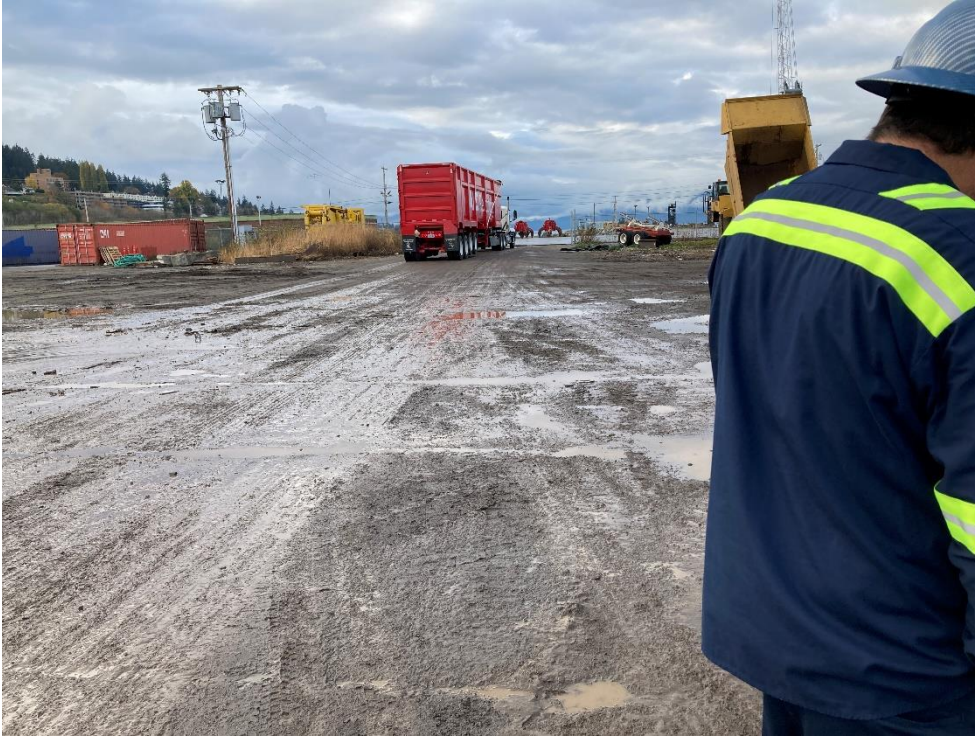
Photo 9

Description: Muddy stockpile yard that has not been stabilized to prevent pollutants from comingling with stormwater.

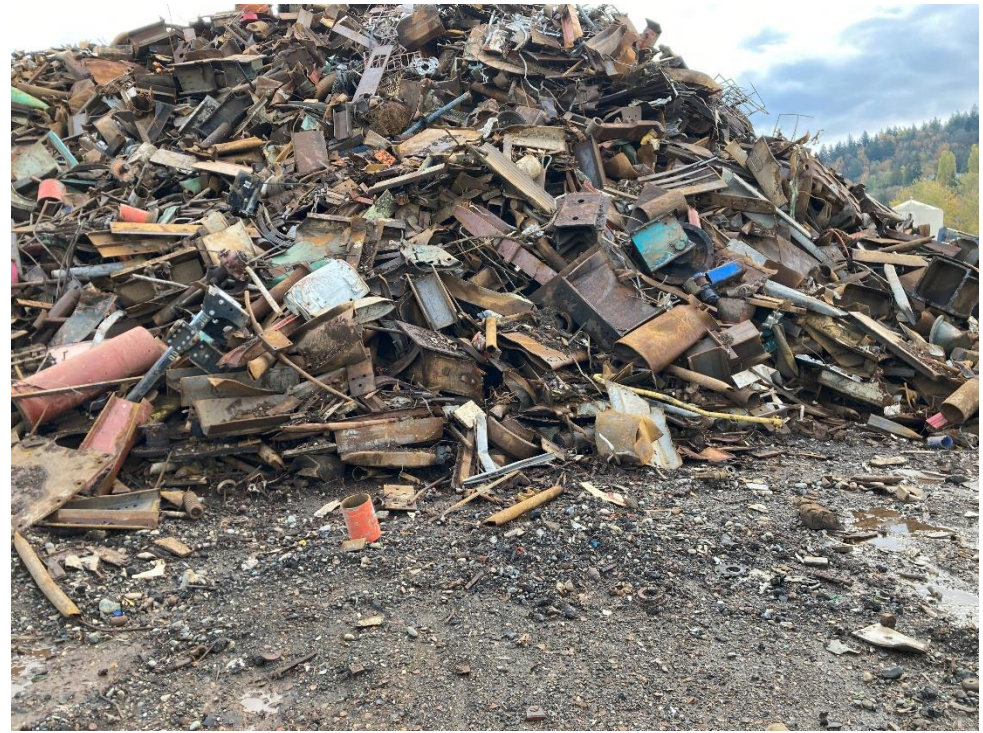
Photo 10

Description: Metal stockpile to be loaded on barges.
