**ABC RECYCLING**  
**OVERALL SITE PLAN 30 SCALE-1**  
 PLAN SET (10-23-2023)  
 741 MARINE DRIVE  
 BELLINGHAM, WASHINGTON 98226

**ABC RECYCLING**  
**PROPOSED STORM BLDG 1 & CONTROL STRUCTURES**  
 741 MARINE DRIVE  
 BELLINGHAM, WASHINGTON 98226

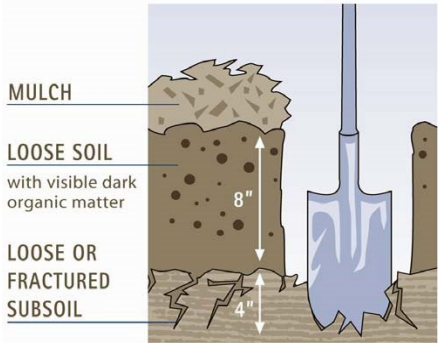
<p>Figure 5.3.3 – Planting Bed Cross-Section (NTS)</p>

<p>resources and critical areas, to be reapplied to other portions of the site where feasible.</p>	<p>The resulting soil should be conducive to the type of vegetation to be established.</p>
<p>▪ <b>Implementation Options:</b> The soil quality design guidelines listed above can be met by using one of the methods listed below:</p> <ol style="list-style-type: none"> <li>1. Leave undisturbed native vegetation and soil, and protect from compaction during construction.</li> <li>2. Amend existing site topsoil or subsoil either at default “pre-approved” rates, or at custom calculated rates based on tests of the soil and amendment.</li> <li>3. Stockpile existing topsoil during grading, and replace it prior to planting. Stockpiled topsoil must also be amended if needed to meet the organic matter or depth requirements, either at a default “pre-approved” rate or at a custom calculated rate.</li> <li>4. Import topsoil mix of sufficient organic content and depth to meet the requirements.</li> </ol> <p>More than one method may be used on different portions of the same site. Soil that already meets the depth and organic matter quality standards, and is not compacted, does not need to be amended.</p> <p><b><u>Planning/Permitting/Inspection/Verification Guidelines &amp; Procedures</u></b></p> <p>Local governments are encouraged to adopt guidelines and procedures similar to those recommended in Guidelines and Resources For Implementing Soil Quality and Depth BMP T5.13 in WDOE Stormwater Management Manual for Western Washington. This document is available at: <a href="http://www.soilsforsalmon.org/pdf/Soil_BMP_Manual.pdf">http://www.soilsforsalmon.org/pdf/Soil_BMP_Manual.pdf</a></p> <p><b><u>Maintenance</u></b></p> <ul style="list-style-type: none"> <li>▪ Establish soil quality and depth toward the end of construction and once established, protect from compaction, such as from large machinery use, and from erosion.</li> <li>▪ Plant vegetation and mulch the amended soil area after installation.</li> <li>▪ Leave plant debris or its equivalent on the soil surface to replenish organic matter.</li> <li>▪ Reduce and adjust, where possible, the use of irrigation, fertilizers, herbicides and pesticides, rather than continuing to implement formerly established practices.</li> </ul>	<p><b><u>Runoff Model Representation</u></b></p> <p>Areas meeting the design guidelines may be entered into approved runoff models as “Pasture” rather than “Lawn.”</p> <p>Flow reduction credits can be taken in runoff modeling when <a href="#">BMP T5.13: Post-Construction Soil Quality and Depth</a> is used as part of a dispersion design under the conditions described in:</p> <ul style="list-style-type: none"> <li>• <a href="#">BMP T5.10B: Downspout Dispersion Systems</a></li> <li>• <a href="#">BMP T5.11: Concentrated Flow Dispersion</a></li> <li>• <a href="#">BMP T5.12: Sheet Flow Dispersion</a></li> <li>• <a href="#">BMP T5.18: Reverse Slope Sidewalks</a></li> <li>• <a href="#">BMP T5.30: Full Dispersion</a> (for public road projects)</li> </ul>

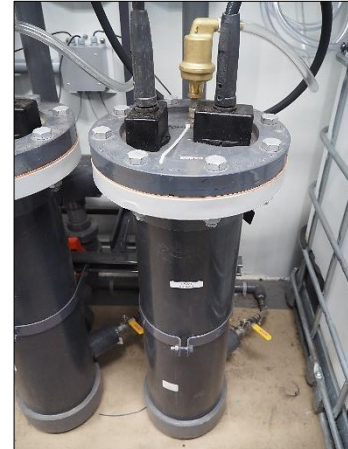
Figure 4: EC Treatment Cell

When an EC Treatment Cell is supplied with electricity, the metal plates become charged, metal ions are released into the water and react with contaminants suspended in the water, making it much easier for them to coagulate and precipitate out during the clarification phase of the water treatment process.

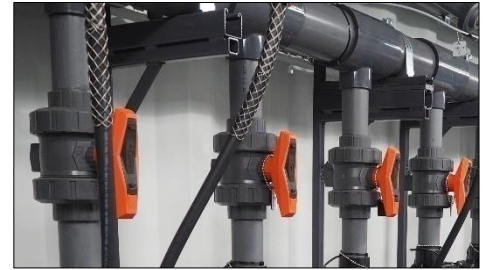
Figure 5: EC Treatment Cell Influent Isolation Valves

Each EC Treatment Cell has two Influent Isolation Valves. During operation, these hand-operated, 2-inch ball valves should remain open to allow water into the EC Treatment Cell. They also act as backups for the electrically actuated EC Flow Valves. Closing both the Influent and Effluent Isolation Valves isolates the individual EC Treatment Cell from the water stream when servicing or replacement of the metal plate assembly is necessary.

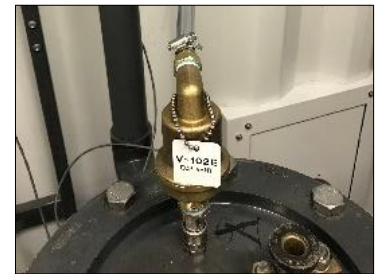
Figure 7: EC Vent Valve

When the metal plates in the EC Treatment Cells become charged, hydrogen gas are released from the water. Each EC Treatment Cell has an air vent that allows hydrogen gas and air to escape, and the cell to fill with water following replacement of the metal plate assembly.

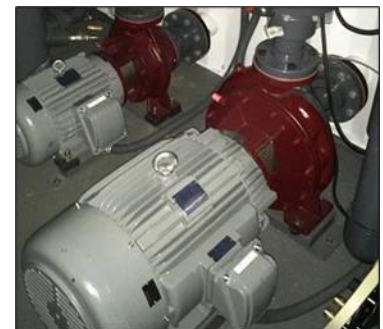
Figure 11: Media Filter Supply Pump

A 480 V 3-phase flooded suction centrifugal pump pushes water from the clearwell tank through the media filter. The clearwell tank is the final settling tank. The control for the media filter supply pump is located on the control cabinet door.

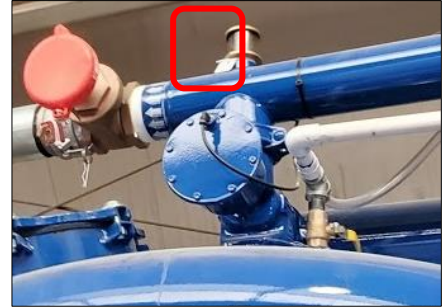
Figure 18: Media Filter Sight Glass

When the backflush flowrate is being set, if sand accumulates in the Sight Glass (SG-231), the backflush flowrate should be lowered using the Backflush Restrictor Valve. Any accumulated sand should clear out of the Sight Glass once water is flowing at the correct flowrate. If regular flow does not clear the Sight Glass and a large amount of sand has accumulated, stop the system, unscrew the bolt, remove the Sight Glass, empty the sand, and replace the Sight Glass.
