Stormwater Management Report

ABC Recycling

October 21, 2023

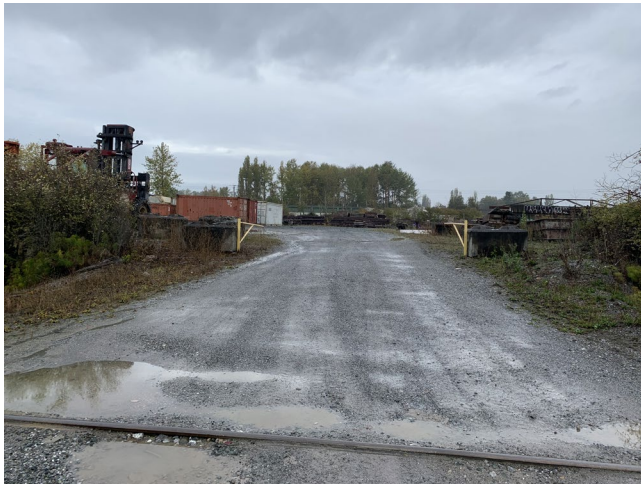
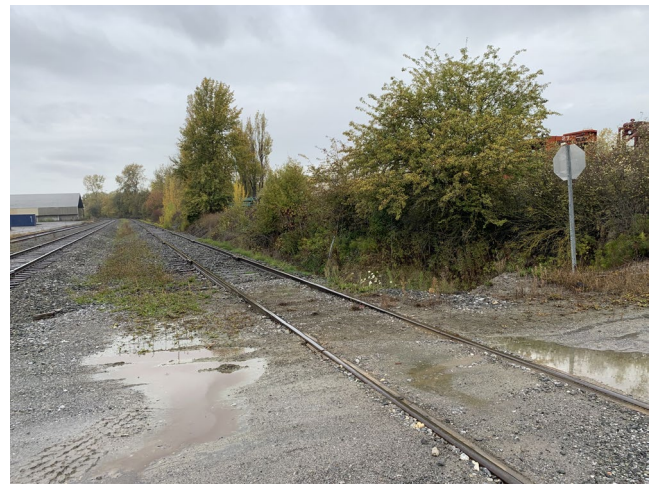
Existing Conditions Site Photos (10/19/2023)

The steepest slope of the property is approximately 5 percent at the northeast property boundary near the Marine Drive right-of-way. Shallow soils at the site consist of mostly uncontrolled fill overlying glacial outwash sand overlying glaciomarine drift clay.

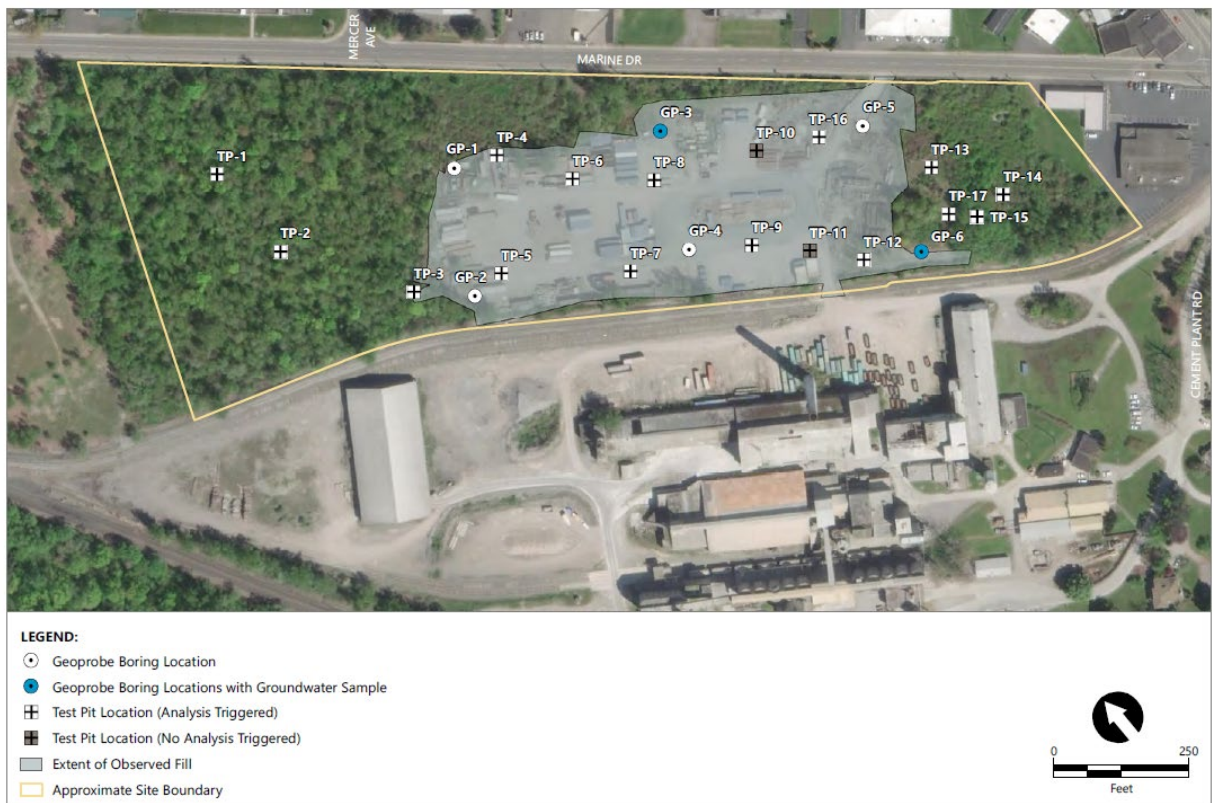
The samples collected from the wooded area on the northern side of the Property were generally composed of moist, fine-grained soils, with the exception of TP-3 (Figure 1). Unique soil characteristics identified at TP-3 are detailed below.

- TP-3 was selected to document conditions in a mound of fill in the woods noted during the September 30 site walk. The mound was composed of fine, limestone-like material. Debris were present on the mound and within the surrounding area. The majority of samples collected from the yard were composed of dry, compacted gravel material that makes up the surface backfill of the yard. Native material was encountered in the yard between 4.5 and 5 feet bgs. Samples with unique soil characteristics are detailed below.*

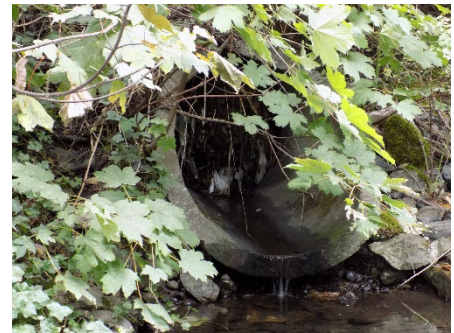
Marine Drive Outfall

At 1,760 feet from the connection to the city storm drain line at the southeast corner of the property, Marine Dr. intersects Little Squalicum Creek. Following the flowpath of the city storm drain line, two 36” concrete pipes were observed to be discharging stormwater runoff into Little Squalicum Creek.

From the outfall at the intersection of Marine Dr. and Little Squalicum Creek stormwater runoff flows 700 feet to the Little Squalicum Estuary where it discharges into Bellingham Bay.

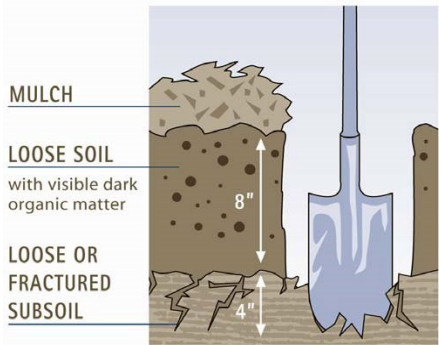
<p>Figure 5.3.3 – Planting Bed Cross-Section (NTS)</p>

<p>resources and critical areas, to be reapplied to other portions of the site where feasible.</p>	<p>The resulting soil should be conducive to the type of vegetation to be established.</p>
<p>▪ Implementation Options: The soil quality design guidelines listed above can be met by using one of the methods listed below:</p> <ol style="list-style-type: none"> 1. Leave undisturbed native vegetation and soil, and protect from compaction during construction. 2. Amend existing site topsoil or subsoil either at default “pre-approved” rates, or at custom calculated rates based on tests of the soil and amendment. 3. Stockpile existing topsoil during grading, and replace it prior to planting. Stockpiled topsoil must also be amended if needed to meet the organic matter or depth requirements, either at a default “pre-approved” rate or at a custom calculated rate. 4. Import topsoil mix of sufficient organic content and depth to meet the requirements. <p>More than one method may be used on different portions of the same site. Soil that already meets the depth and organic matter quality standards, and is not compacted, does not need to be amended.</p> <p><u>Planning/Permitting/Inspection/Verification Guidelines & Procedures</u></p> <p>Local governments are encouraged to adopt guidelines and procedures similar to those recommended in Guidelines and Resources For Implementing Soil Quality and Depth BMP T5.13 in WDOE Stormwater Management Manual for Western Washington. This document is available at: http://www.soilsforsalmon.org/pdf/Soil_BMP_Manual.pdf</p> <p><u>Maintenance</u></p> <ul style="list-style-type: none"> ▪ Establish soil quality and depth toward the end of construction and once established, protect from compaction, such as from large machinery use, and from erosion. ▪ Plant vegetation and mulch the amended soil area after installation. ▪ Leave plant debris or its equivalent on the soil surface to replenish organic matter. ▪ Reduce and adjust, where possible, the use of irrigation, fertilizers, herbicides and pesticides, rather than continuing to implement formerly established practices. 	<p><u>Runoff Model Representation</u></p> <p>Areas meeting the design guidelines may be entered into approved runoff models as “Pasture” rather than “Lawn.”</p> <p>Flow reduction credits can be taken in runoff modeling when BMP T5.13: Post-Construction Soil Quality and Depth is used as part of a dispersion design under the conditions described in:</p> <ul style="list-style-type: none"> • BMP T5.10B: Downspout Dispersion Systems • BMP T5.11: Concentrated Flow Dispersion • BMP T5.12: Sheet Flow Dispersion • BMP T5.18: Reverse Slope Sidewalks • BMP T5.30: Full Dispersion (for public road projects)

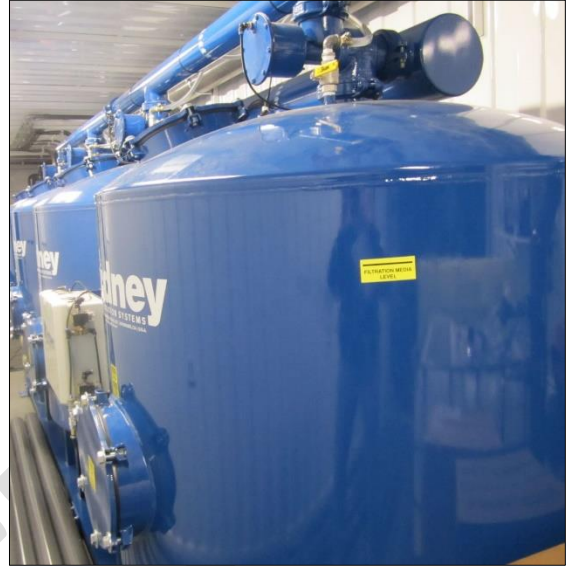
Figure 1: Example Media Filter

The media filter requires periodic backflushing (reversing the flow in each of the pods individually) to remove filtered sediment and debris from the media bed. Backflushing can be manual, timed, or automatic. The automatic backflush feature is based on the pressure differential between the influent and effluent sides of the media filter.

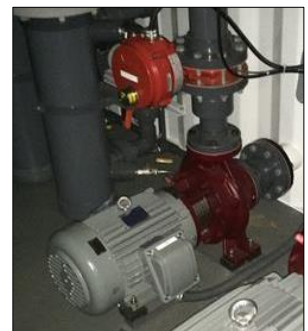
Figure 3: EC Supply Pump

A 480 V 3-phase flooded suction centrifugal pump moves water through the EC stage. The pump is controlled by the EC PUMP switch on the control cabinet door. The operator can select from HAND (Manual), OFF, and AUTO operation.

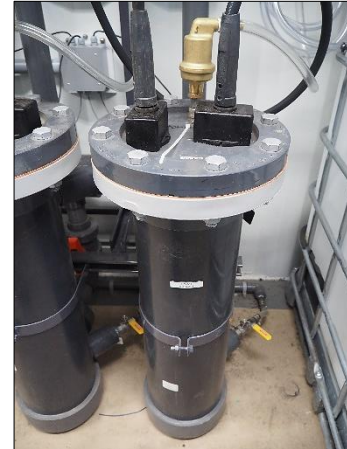
Figure 4: EC Treatment Cell

When an EC Treatment Cell is supplied with electricity, the metal plates become charged, metal ions are released into the water and react with contaminants suspended in the water, making it much easier for them to coagulate and precipitate out during the clarification phase of the water treatment process.

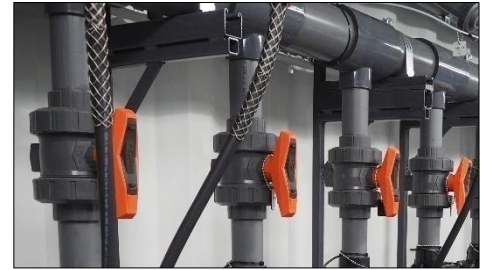
Figure 5: EC Treatment Cell Influent Isolation Valves

Each EC Treatment Cell has two Influent Isolation Valves. During operation, these hand-operated, 2-inch ball valves should remain open to allow water into the EC Treatment Cell. They also act as backups for the electrically actuated EC Flow Valves. Closing both the Influent and Effluent Isolation Valves isolates the individual EC Treatment Cell from the water stream when servicing or replacement of the metal plate assembly is necessary.

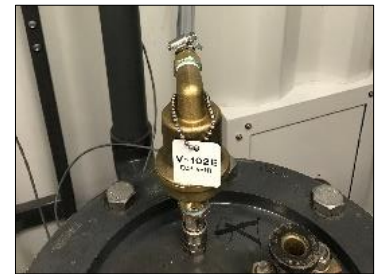
Figure 7: EC Vent Valve

When the metal plates in the EC Treatment Cells become charged, hydrogen gas are released from the water. Each EC Treatment Cell has an air vent that allows hydrogen gas and air to escape, and the cell to fill with water following replacement of the metal plate assembly.

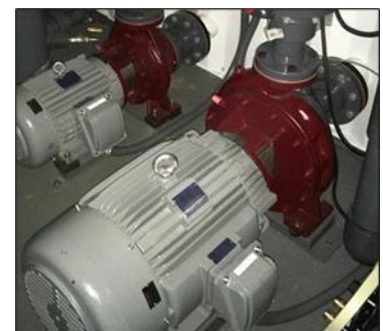
Figure 11: Media Filter Supply Pump

A 480 V 3-phase flooded suction centrifugal pump pushes water from the clearwell tank through the media filter. The clearwell tank is the final settling tank. The control for the media filter supply pump is located on the control cabinet door.

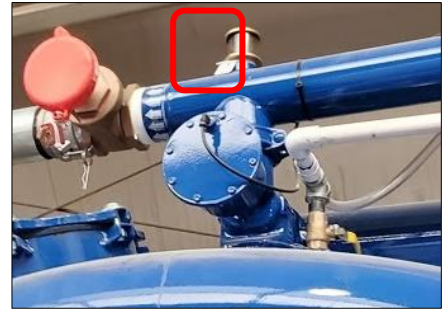
Figure 18: Media Filter Sight Glass

When the backflush flowrate is being set, if sand accumulates in the Sight Glass (SG-231), the backflush flowrate should be lowered using the Backflush Restrictor Valve. Any accumulated sand should clear out of the Sight Glass once water is flowing at the correct flowrate. If regular flow does not clear the Sight Glass and a large amount of sand has accumulated, stop the system, unscrew the bolt, remove the Sight Glass, empty the sand, and replace the Sight Glass.

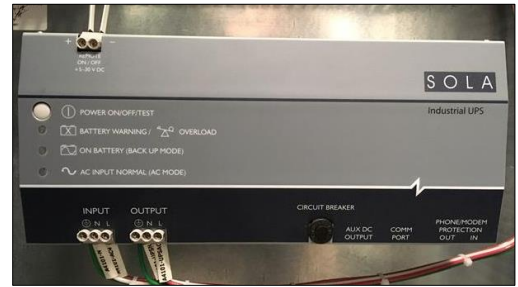
Figure 34: Uninterruptable Power Supply

There is an Uninterruptable Power Supply (UPS) located inside the control cabinet. In the event of a power failure, it is used to close the EC isolation valve (V-EC). Closing the valve prevents siphoning through the systems. The UPS is controlled by the PLC, which powers up the UPS when power is restored to the system.

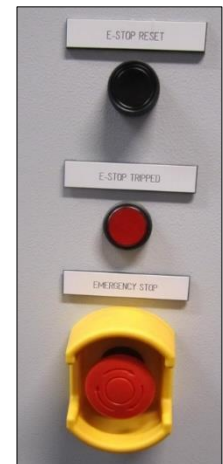
Figure 39:
Emergency
Stop

To reset the E-Stop, first rotate the button clockwise. Then press the E-STOP RESET button.
